Oscilloscope Restoration Project – Repair Tektronix 2465B 400MHz

This applies to all similar type models 2445 , 2445A , 2445B , 2465 , 2465A , 2465B , 2467 , 2467A , 2467B and others which share common circuit boards.

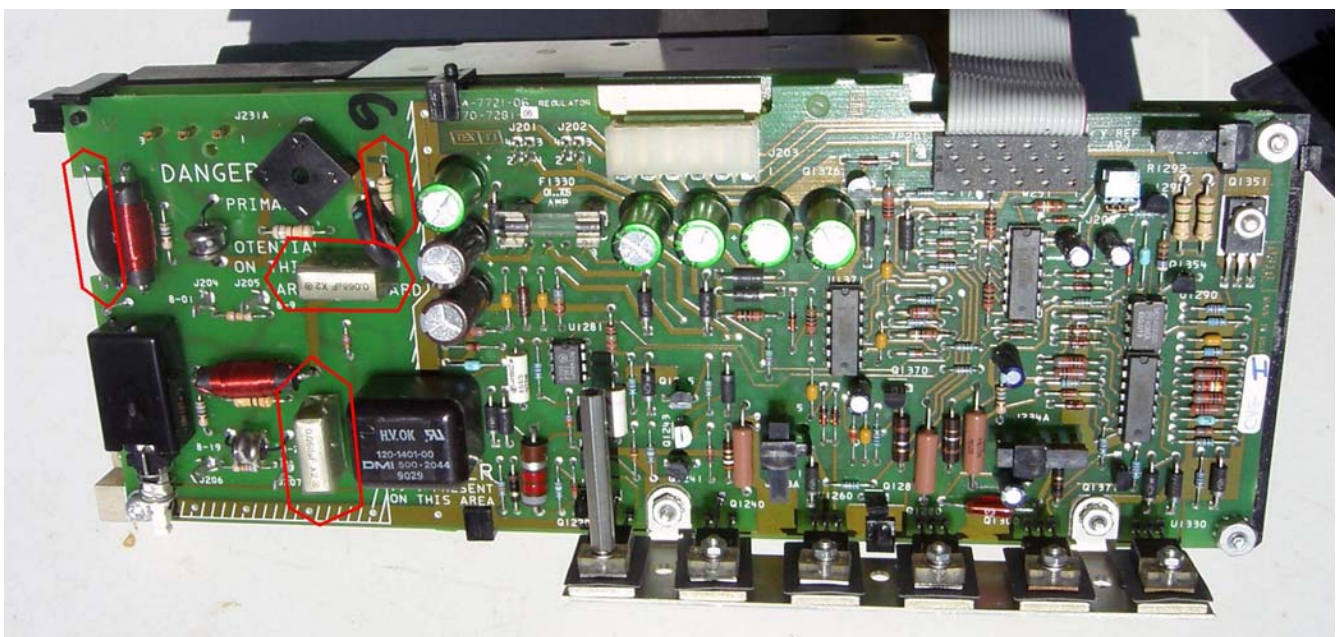
Here is the A2 PCB before restoration, with the AC High-voltage section on the left.

I disconnected the High-voltage section from the Low-voltage section. There are 2 test points in the high-voltage section, and both should read the same. Mine read 160V, and 195V respectively.

On the left, are 4 components circled in red. These were the faulty components.

1. R1010 and R1019 - 15 ohm resistors, which were replaced by Ohmite blue ceramic 5W units.
2. C1016 and C1018 - 68nF type X2, which were replaced by Vishay MKP339 AC type X2 units.
3. In addition, I replaced C1021 and C1022 - the large Sprague 290uF power capacitors with Panasonic TSHA 330uF 250V units.

After these changes, the high-voltage section was stable with equal voltage at the 2 test points.

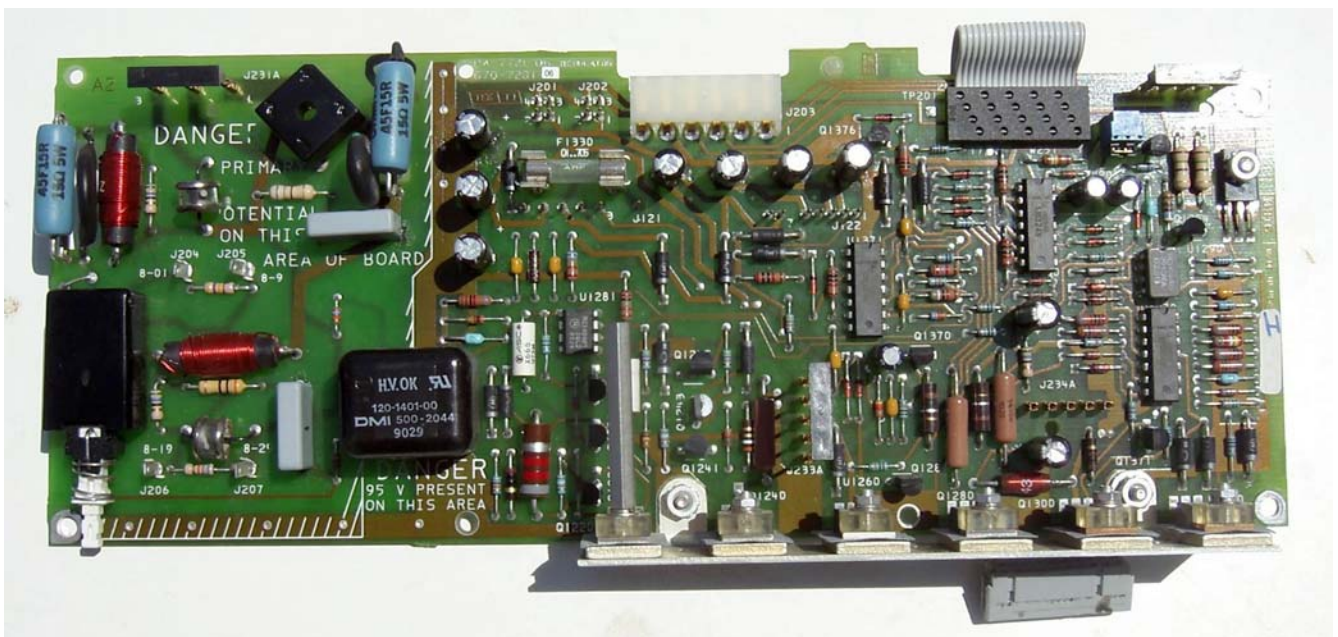
Here is the A2 PCB after restoration, with all the new components clearly visible

Even though the ESR's of the electrolytic capacitors (in the low-voltage section) were within limits, I elected to change all of them as well, using Panasonic EB and Nichicon PW units. This was because of all the postings in the Tek forum relating to the certainty of capacitor degradation in the PSU.

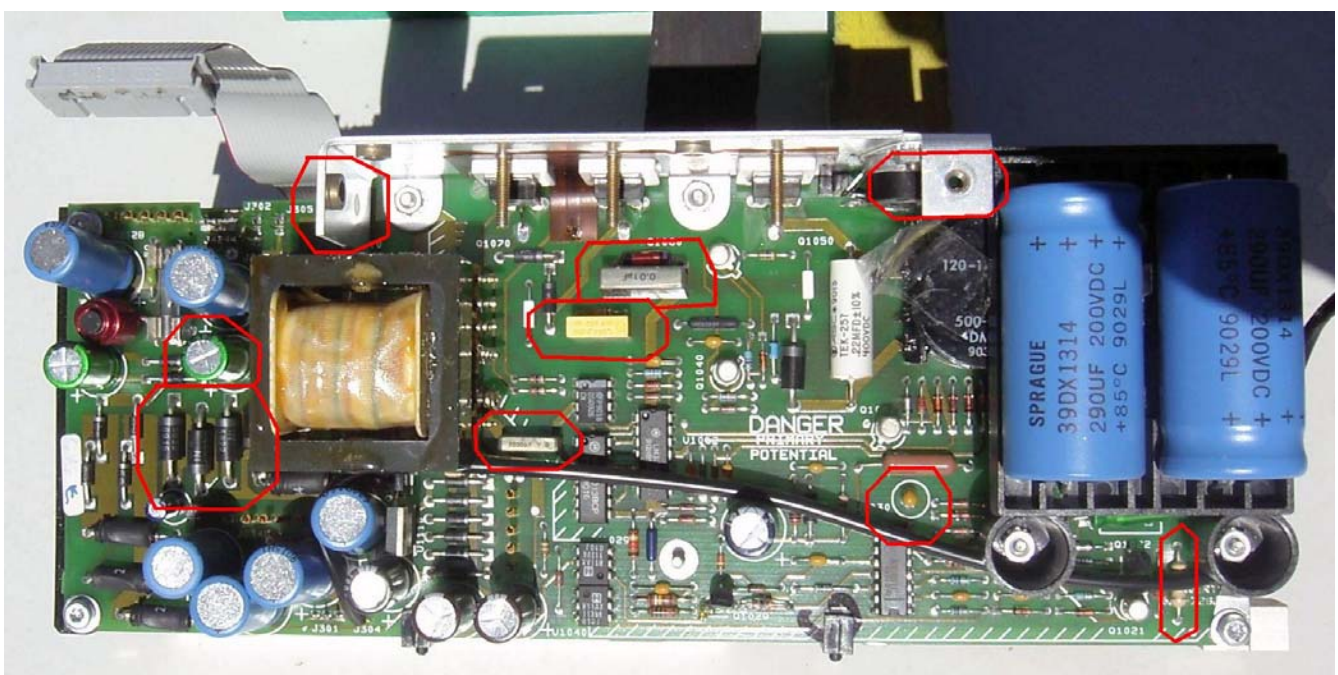
Here is the A3 PCB before restoration.

Troubleshooting led me first to 4 Schottky rectifiers CR1113-16, circled in red to the left of the transformer. 2 of them were defective, and I replaced all 4 with new 1N5822 units.

Tantalum capacitors are one of my favorite causes of problems, and sure-enough C1034 (to the left of the blue Sprague capacitors) had high ESR. I replaced it with a Panasonic EB 4.7uF unit.

I checked all the semiconductors - all checked OK, except for CR1110, a dual common-cathode Schottky rectifier (circled in red above the transformer). This Tek part is NLA, and I had to have a good look at the circuit to determine an acceptable substitute. This is a 1/2 bridge switching circuit, with output for 5V, with 2 fuse protections of 5A. I selected a Vishay MBR40H45CT-E3/45.

For good measure, I checked the 4 film capacitors, having had experience on the A2 PCB already. They were all more than 10% off-spec.

C1101 (to the left of the transformer) must be exactly 100uF, as it is a coupling capacitor responsible for providing exactly -8V. It cannot be substituted with any other value. Needless to say it was nowhere near 100uF. I now replaced all the electrolytic capacitors on the A3 PCB with Panasonic EB and Nichicon PW units. All the 180uF and 250uF capacitors can be easily replaced with 330uF 50V units.

R1020 at the bottom right-hand corner operates under high stress. I replaced it with a Vishay 270Kohm PR03 3W unit.

1. C1020 and C1051 with Vishay 2200pF MKP3386 AC type Y2 units,
2. C1052 with a Vishay 10nF MKP3366 AC type Y2 unit,
3. C1065 with a Vishay 56nF MKT372 DC unit.

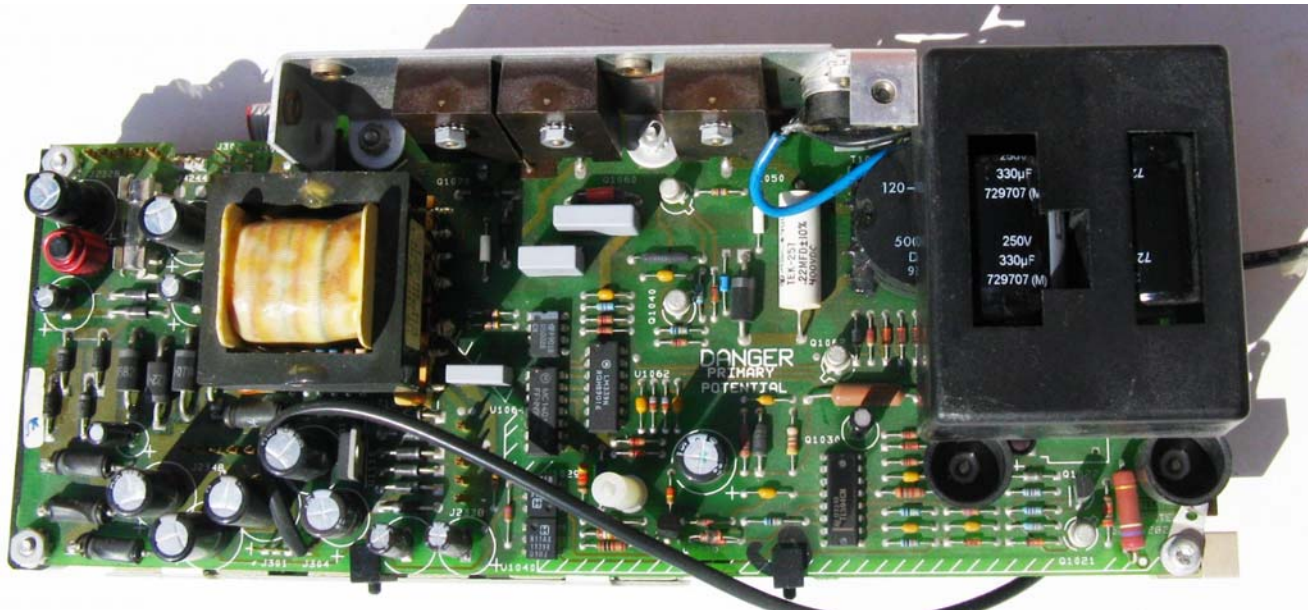
Here is the A3 PCB after restoration.

I now reassembled the PSU, and reinstalled it. At power switch-on, my trusty 'scope started normally. Hallelujah!

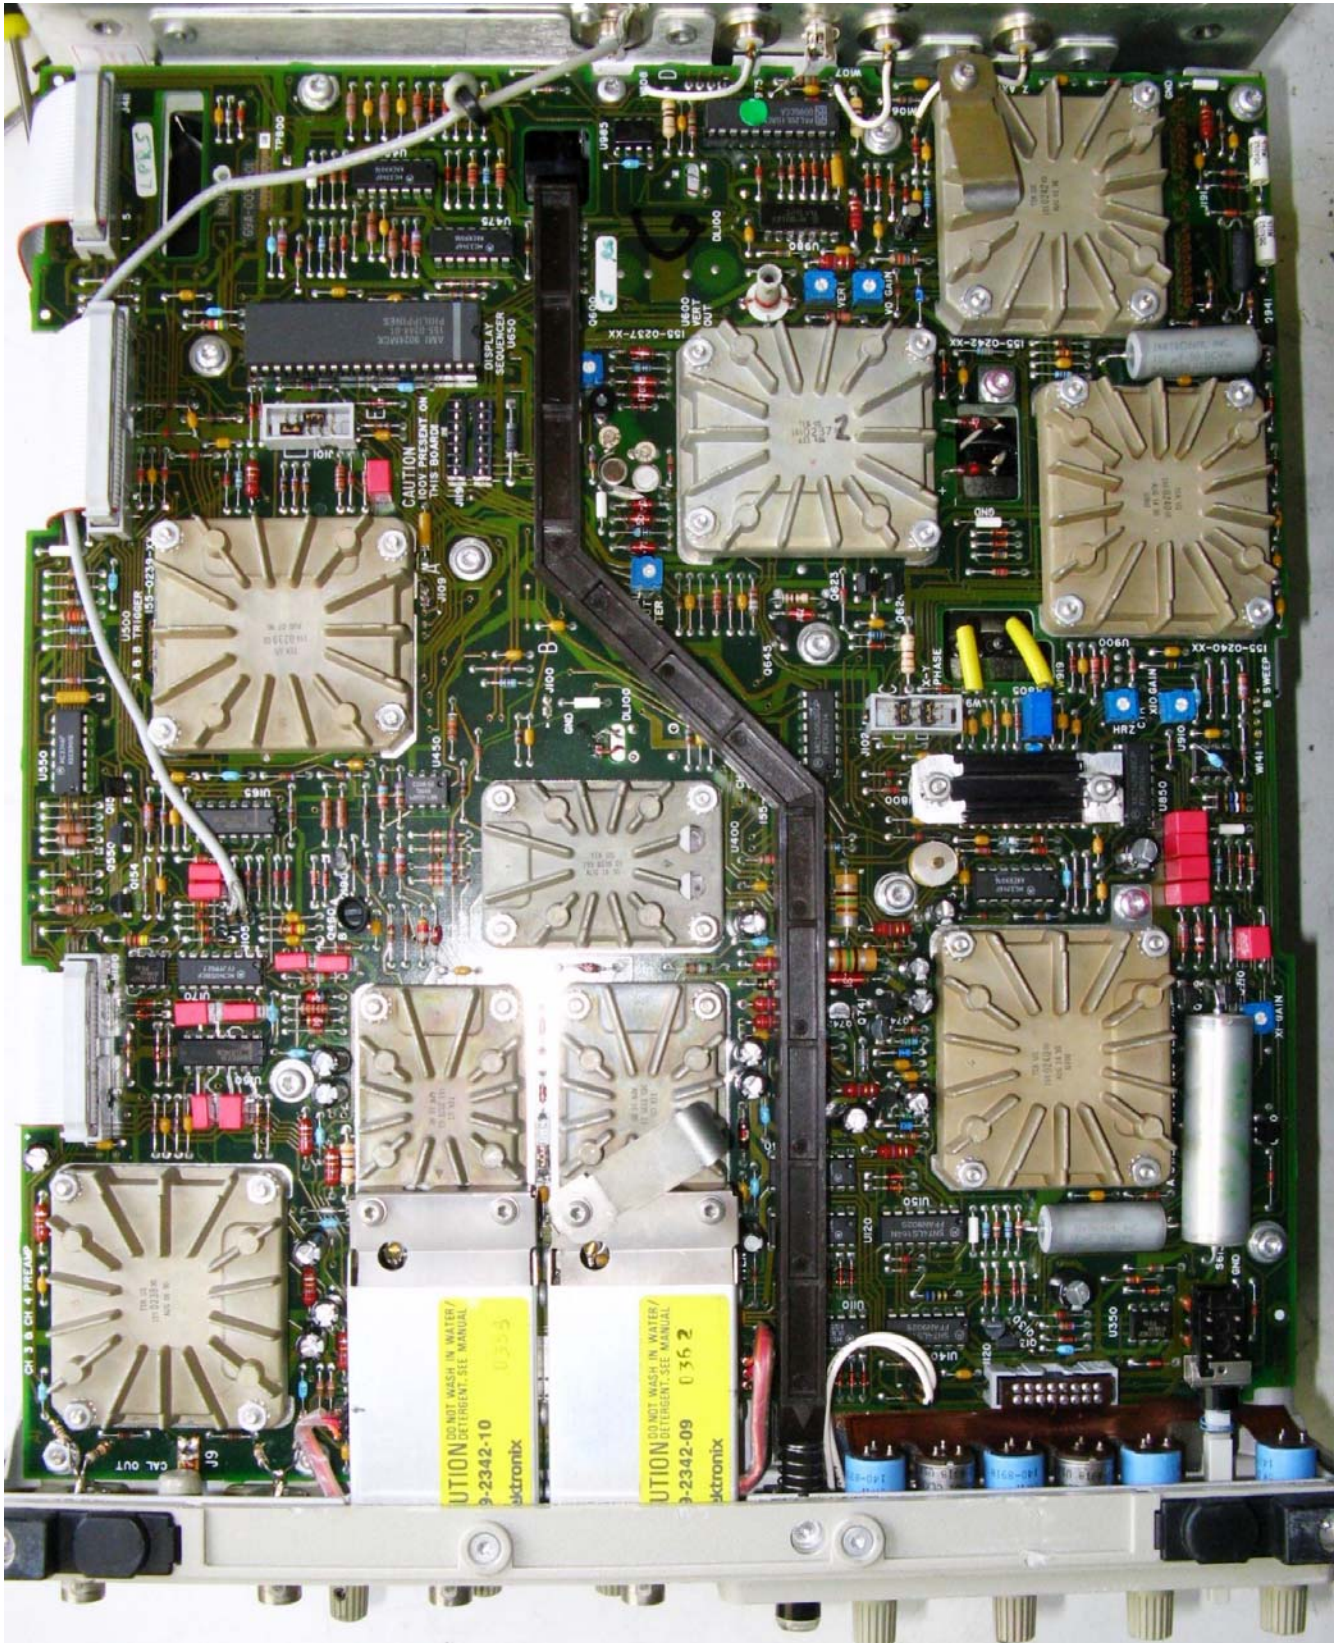
Here is the A1 Main PCB after restoration. The new heat-sink is evident to the right of the kink in the black plastic stem for the On-Off switch. All the new electrolytic capacitors are also clearly visible.

2. U800 Hybrid Horizontal Amplifier failure. I installed an aluminum heat sink on the original Tek (not Maxim) chip.

3. I replaced all the original 85°C Nichicon electrolytics on the A1 Main PCB with Panasonic EB units. This provided me with an immediate and markedly visible improvement of the clarity and sharpness of the signal trace on the CRT display. Not a quick and easy job, but very well worth it.
