Journal notes on Blaupunkt Berlin IQR83 restoration

- This power point contains random information I've collected while restoring and modifying of my Blaupunkt Berlin IQR 83 car radio set.
- I've made them to organize my thinking and analysis. My work has been following a fuzzy path and that is reflected here.

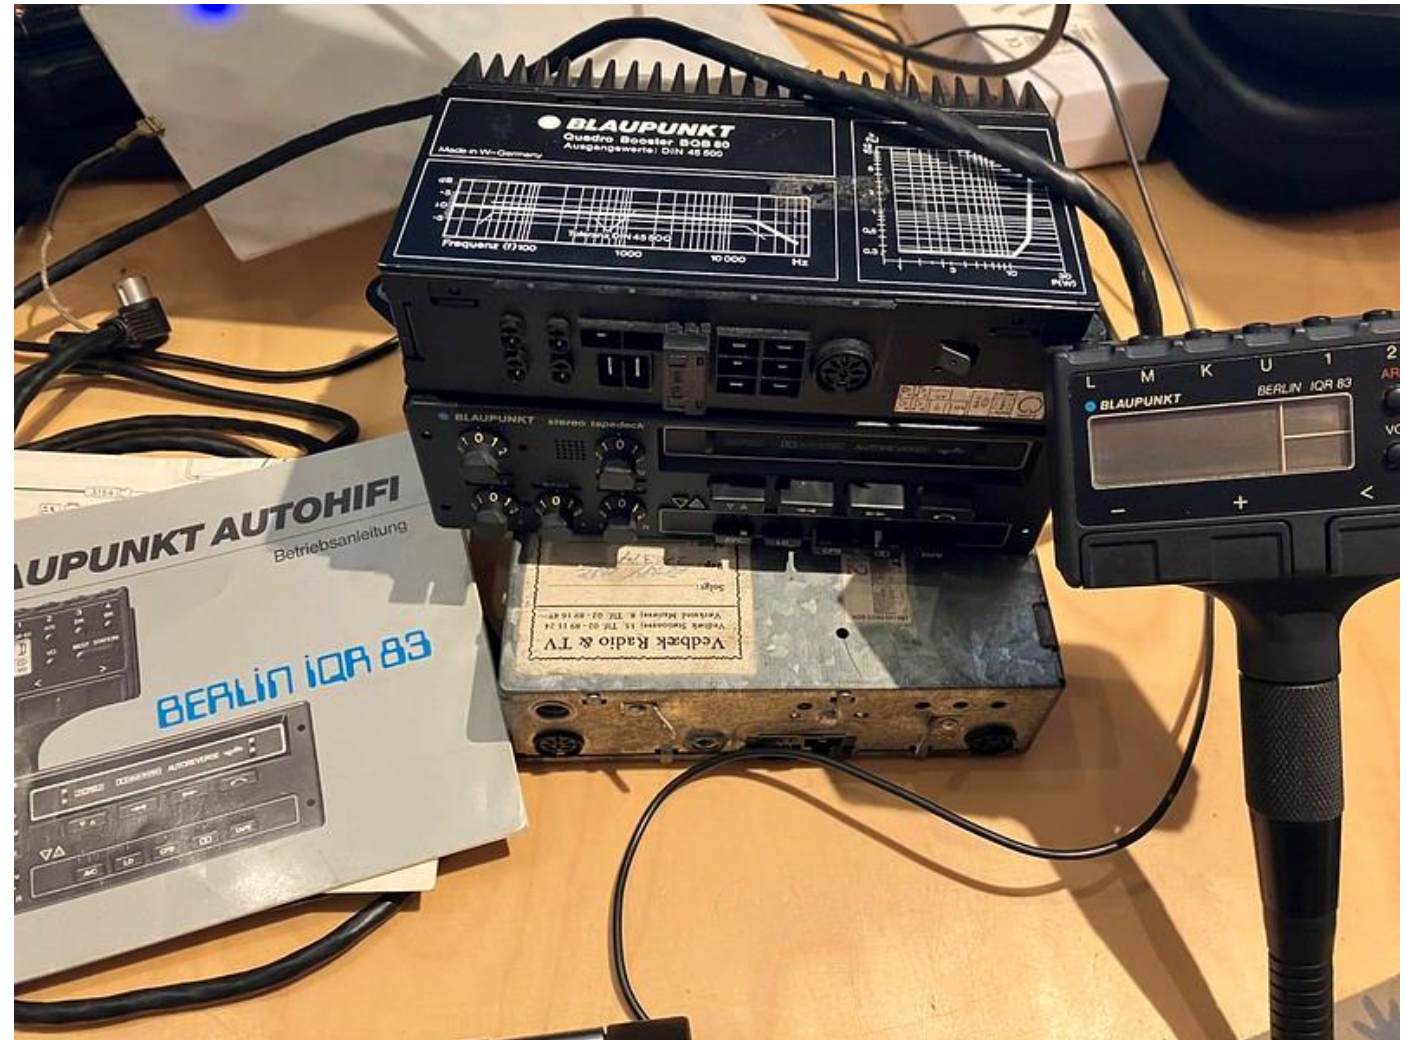
BQB 80

The booster amp is based on eight TDA2003 power amplifier chips in bridge coupling two-and-two to form the four channels. Output power is specified to be 15W RMS per channel, which seems realistic, though the THD curve shown on the box indicates that 10W RMS is the most which is achievable at reasonable distortion levels. That's still a decent power level in a car by 1980's standards.

The schematic is pretty straight forward with each of the four channels modelled after the same recipe.

There are speaker inputs with 4.8 and 6.3 mm tabs and inputs from the tape deck through the 8 pin DIN connector. The speaker inputs are obviously high level, but the DIN input seems to be high level as well. A voltage divider at the input reduces the sign. by -24 dB and -27 dB respectively for the DIN and speaker inputs. The voltage gain of the TDA 2003 in standard coupling is 40 dB according to the datasheet but since they are bridged, in total, the booster probably provides sound level amplification of 13 – 18 dB.

Update: All electrolytes have been replaced. The 2200 uF and 220 uF electrolytes had degraded significantly to 5-700 uF and ~150 uF respectively. The 1 uF seems ok, but was replaced. Cooling of TDA2003 chips has been improved by using paste between them, the mica shims and the heat sink.

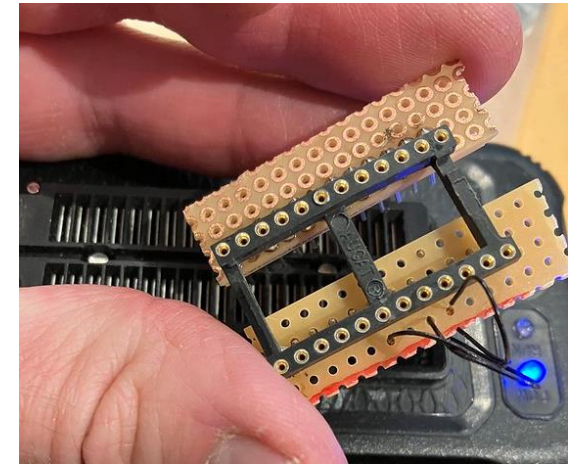
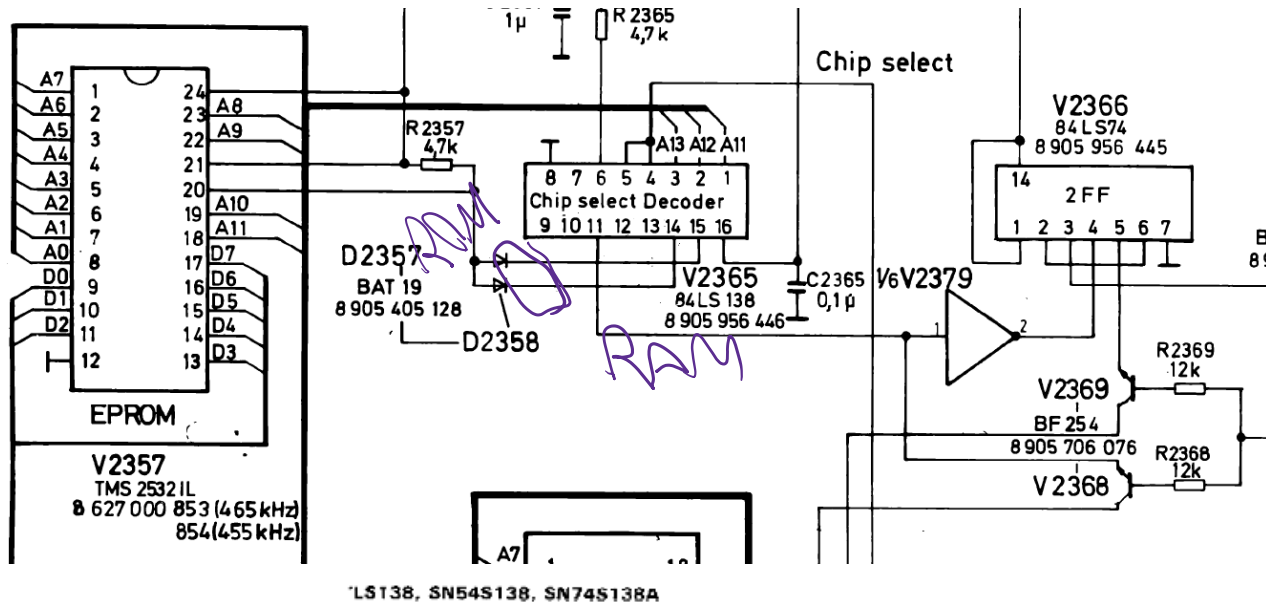
Chip select decoder of the circuit works like this

A13 = 0 and A12 = 0 => enable ROM, meaning that the 4K ROM is mapped from 0000-0FFF

A13 = 1 and A12 = A11 = 0 => enable RAM, meaning 256 byte RAM is mapped from 2000-3FFF

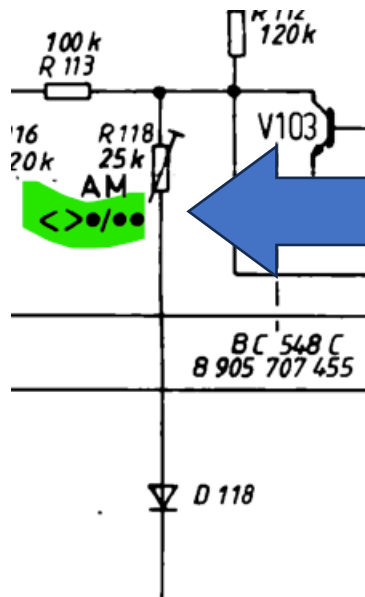
- At the core of the circuit is the TDA 1072 AM Receiver.
- AM PLL seems to work as frequency at PIN 10 = dialed frequency + 450 KHz exactly
- However there is no audible signal at the audio output pin 6, only noise.
- A longer aerial helps, but still no sign of an audio signal, only noise.
- This is recorded directly from PIN 6

This symbol is used in the diagram, but I'm unsure what it means. It's controlled by the computer. It could be a sensitivity setting that I should play with? The trimmer shown here is in the input stage before the TDA 1072.

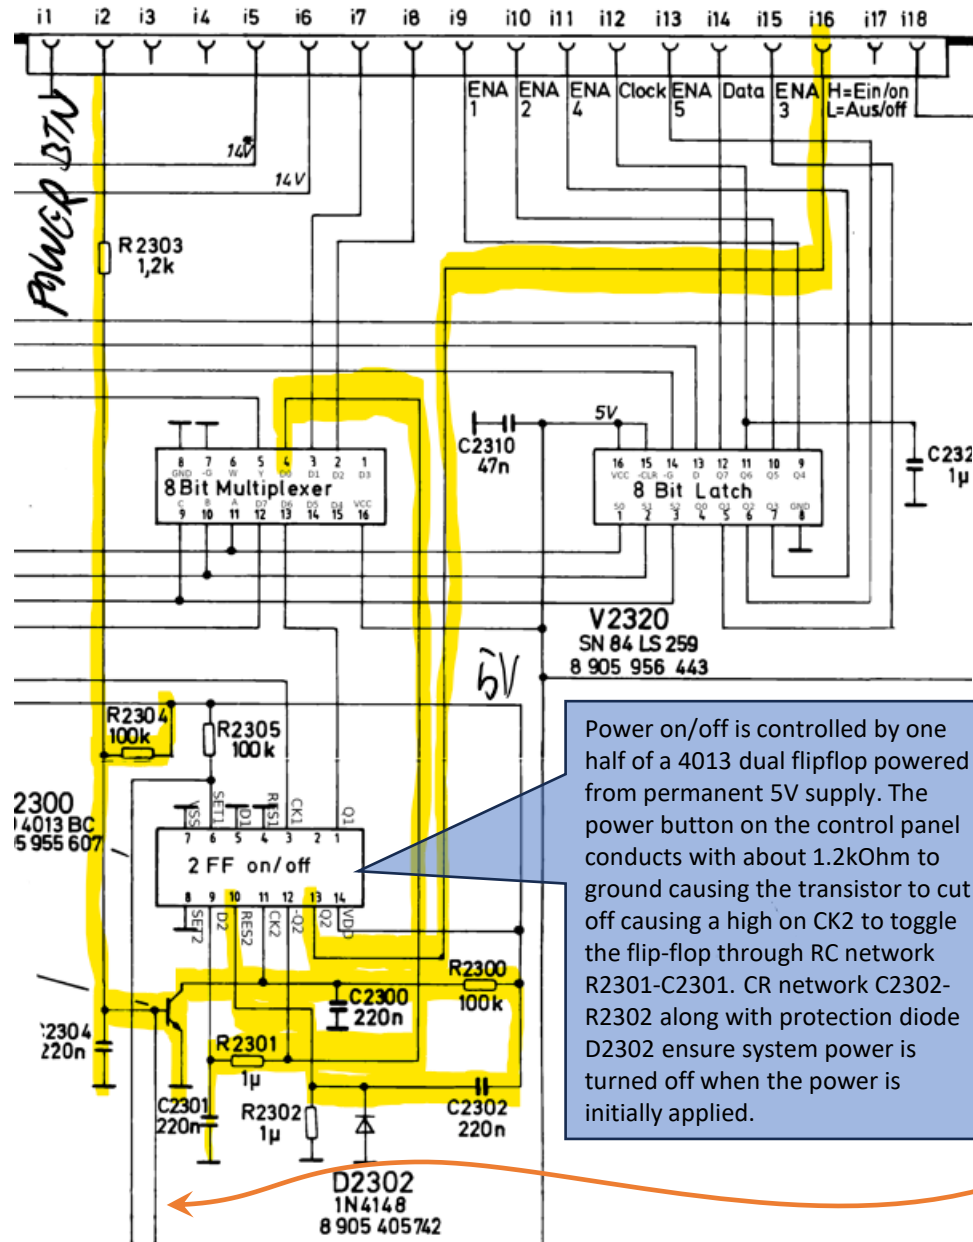
Power on/off control

While checking power supply voltages to the radio, I ran into a problem with power switching off the unit every time I touched the 8V supply to the AM radio with my multimeter. Also, I could not switch on when I had the probe on. This lead me to take a closer look at the power on/off control circuit.

Power on/off is controlled by one half of a 4013 dual flipflop powered from permanent 5V supply. The power button on the control panel conducts with about 1.2kOhm to ground causing the transistor to cut off causing a high on CK2 to toggle the flip-flop through RC network R2301-C2301. CR network C2302-R2302 along with protection diode D2302 ensure system power is turned off when the power is initially applied.

- Possible root causes:
- Mechanical issue with the power button in the control panel
 - Electrical problem around zener diode D2307
 - Electrical problems around the CR network C2302-R2302 causing spurious power off
 - Problem with the 8V supply?

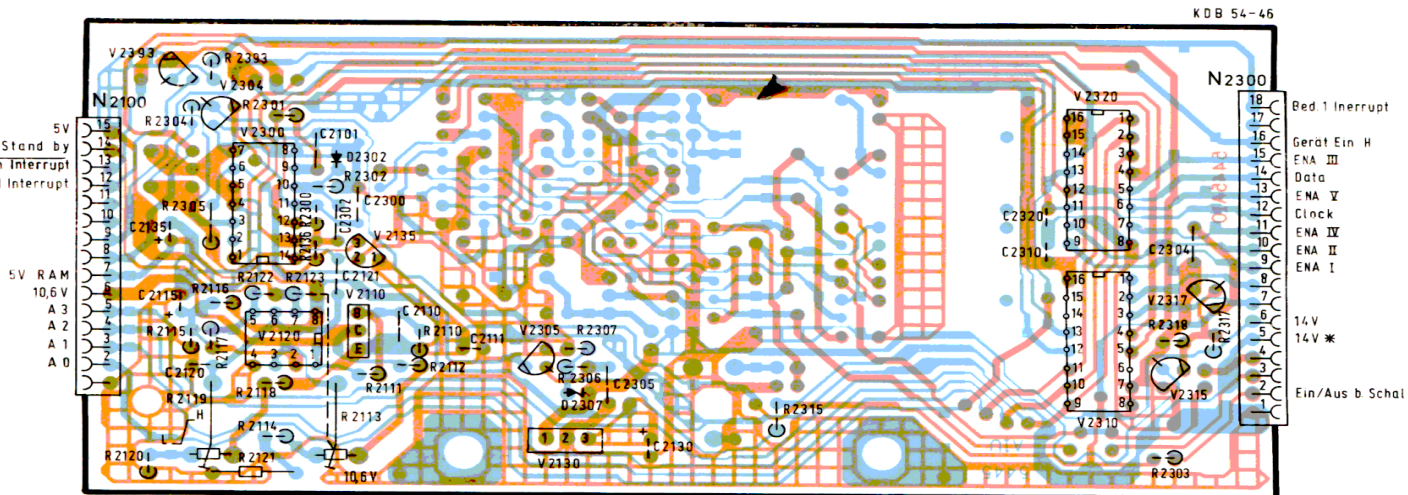
"10.6V" is actually 12.0V supply to the TMS9981

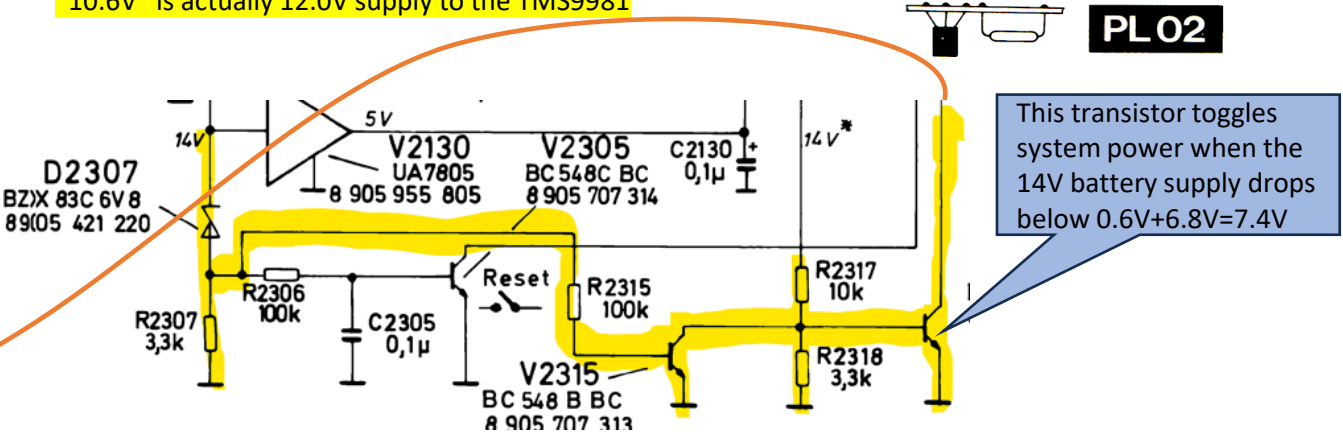
This transistor toggles system power when the 14V battery supply drops below $0.6V + 6.8V = 7.4V$

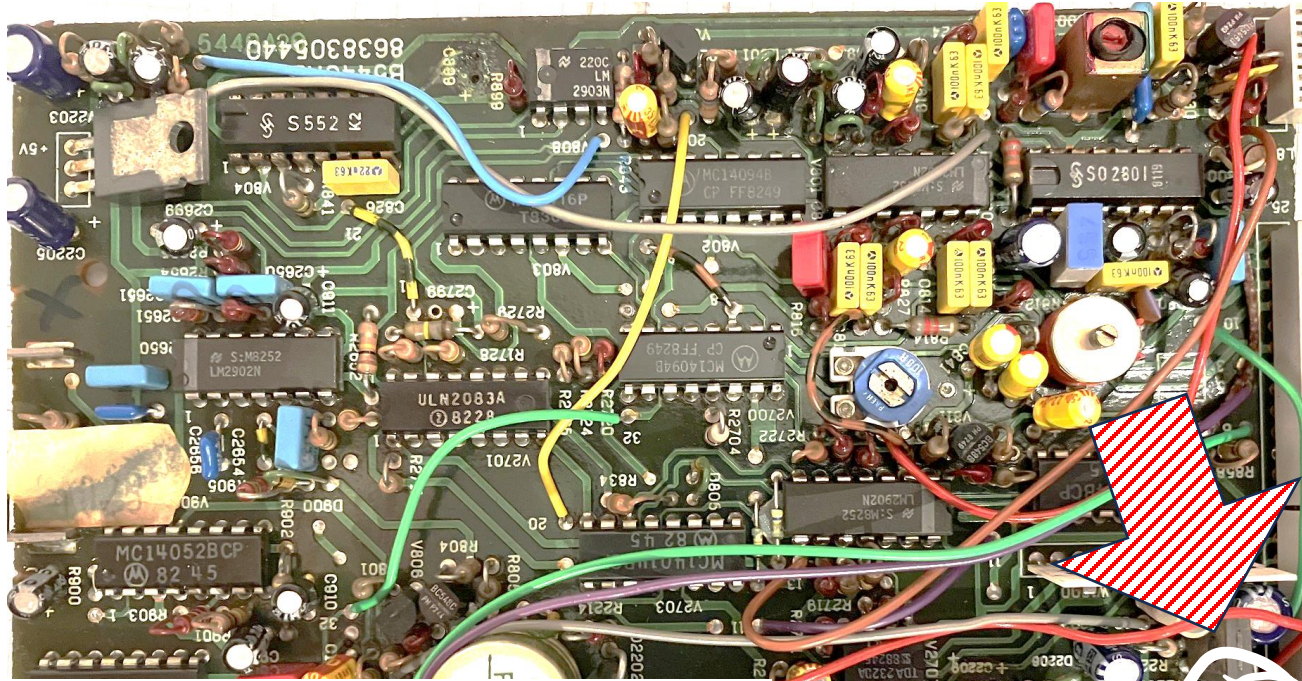
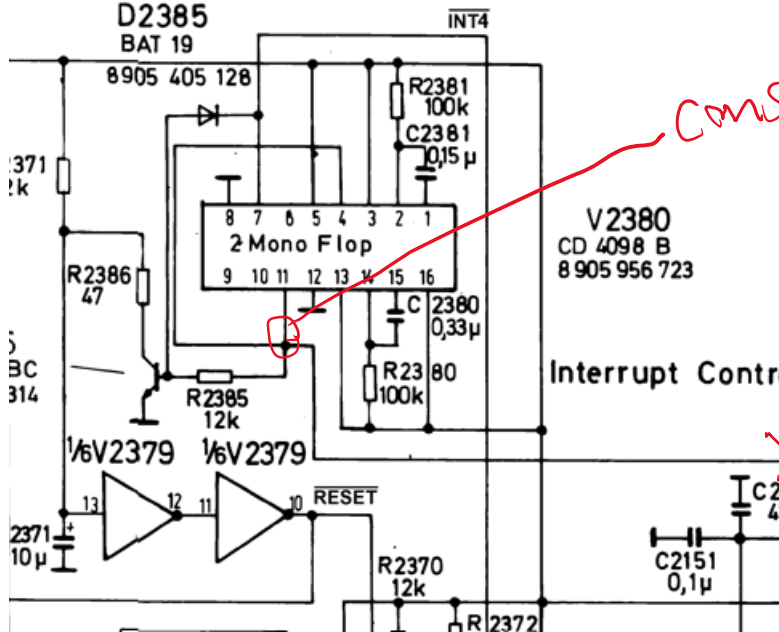
Power-on problem

The problem with the 8V supply seems to be mechanical. However, inspecting the main connection board with the power supply, there are several cooked electrolytes that have leaked their stuff on the board. They need to be replaced. A new problem has developed and the system does not power on now! What's wrong must be investigated.

It turned out the problem was the V2201 transistor and resistors R2201 and R2200. The transistor was bent over because of the DIN connector to the control panel. Also the resistors were touching each other causing a short circuit. Once this was rectified the system could power on- and off and remain on even when touching parts.

CPU did not get out of reset status because the adjustment of R2119 was distorted (probably by me while working with the board)

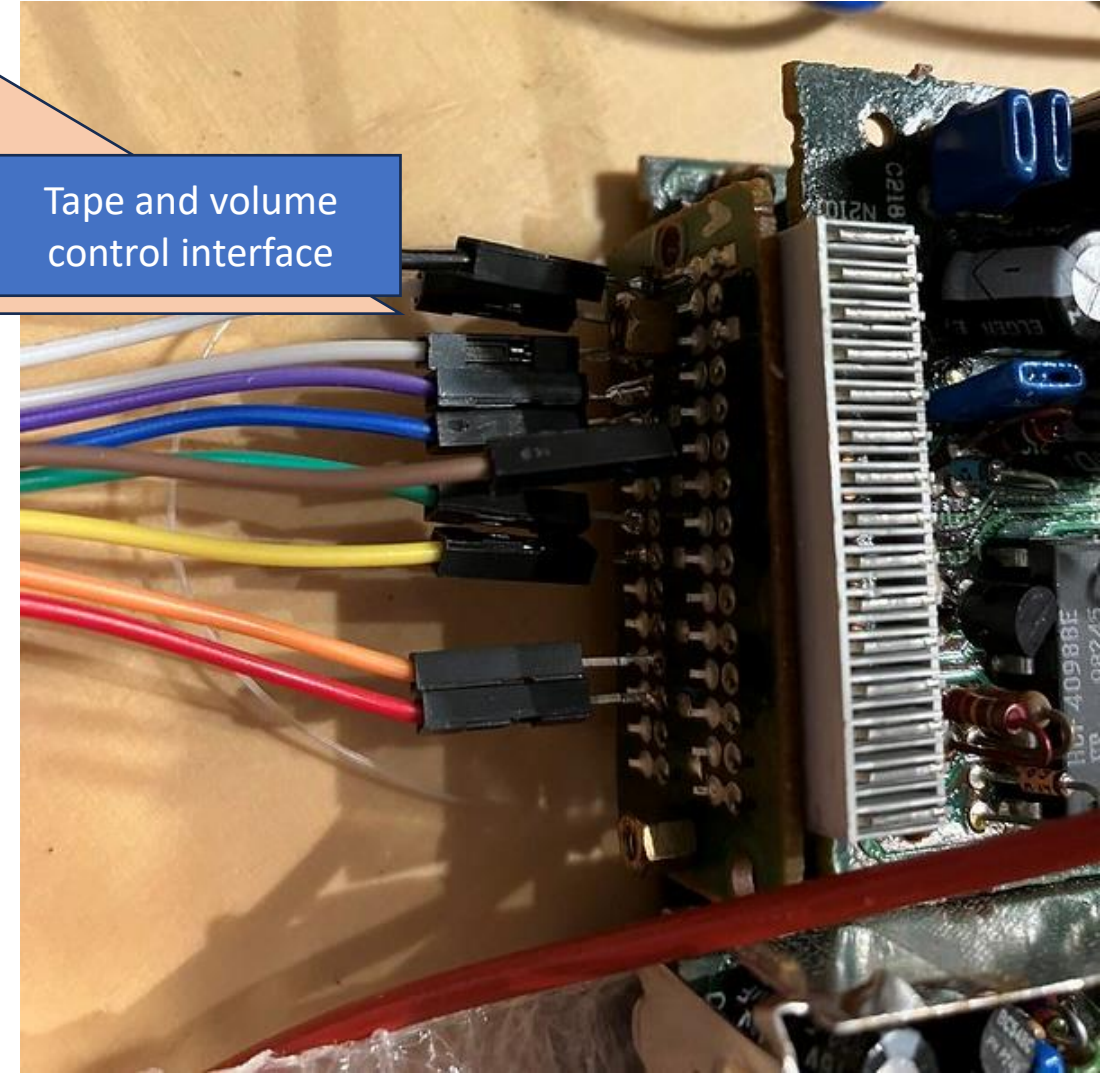
Reverse engineering interfaces

I am tapping into and recording the eight yellow marked signals. My plan is to write a C program that interprets the data.

The table below outlines the CRU I/O connections to interfaces. All interfaces are via shift registers. The schematic on the lower right shows the 74LS259-based CRU out decoder and is redrawn from the schematics.

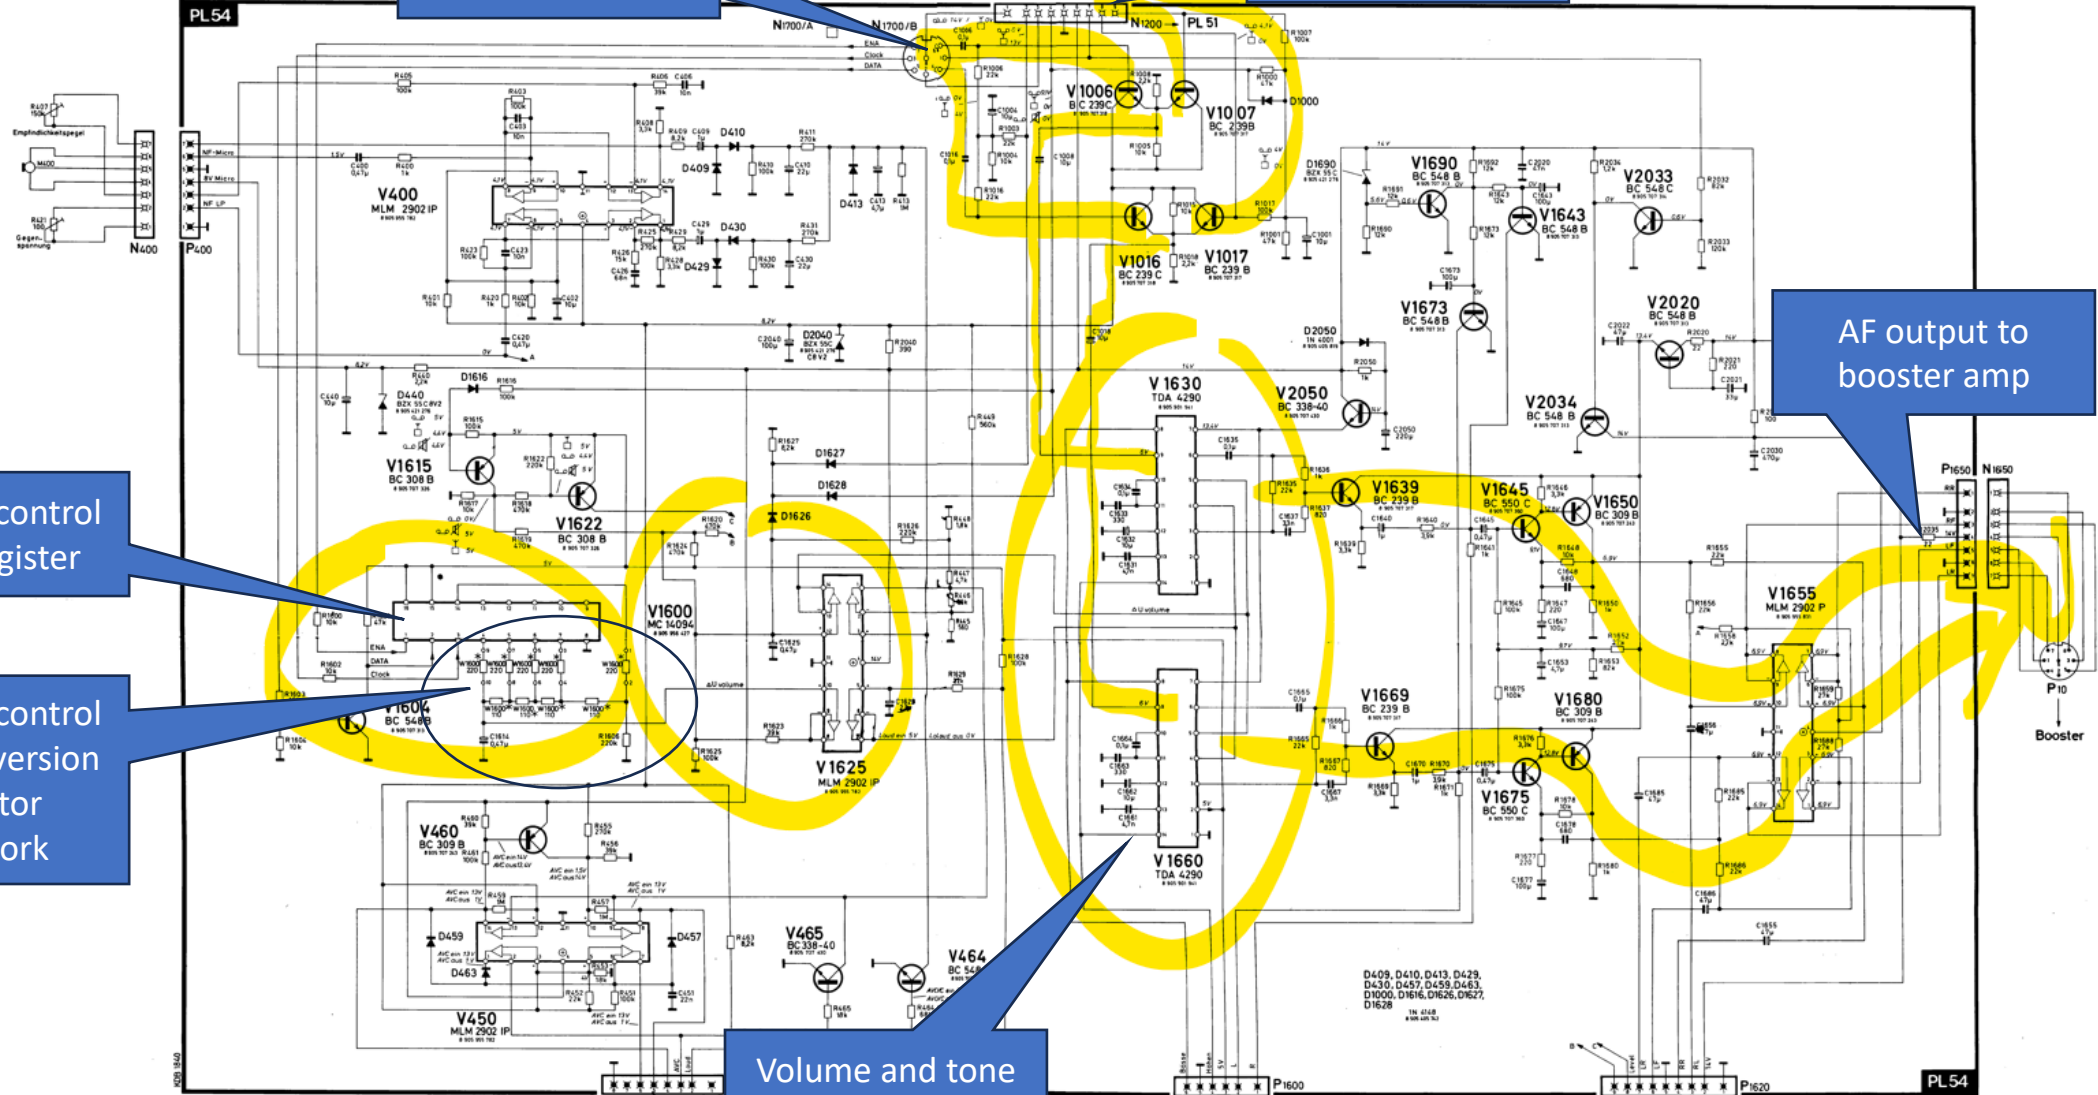
AF input from radio

AF input from tape deck

AF output to booster amp

Volume control shift register

Volume control D-A conversion resistor network

Volume and tone control IC's

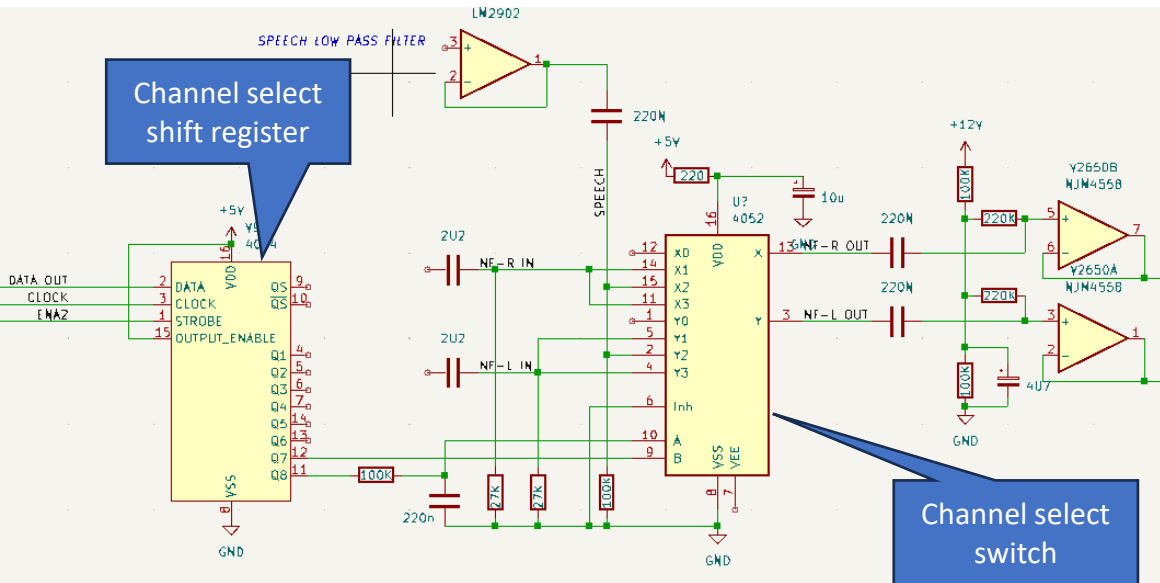
Channel select

- Q8,Q7 = 00_{binary} => floating input
 - Q8,Q7 = 01_{binary} => radio
 - Q8,Q7 = 10_{binary} => speech synth
 - Q8,Q7 = 11_{binary} => radio
- } Latched out with ENA2

The 220nF capacitor on the Q8 output means that there is a short break in the sound when it switches.

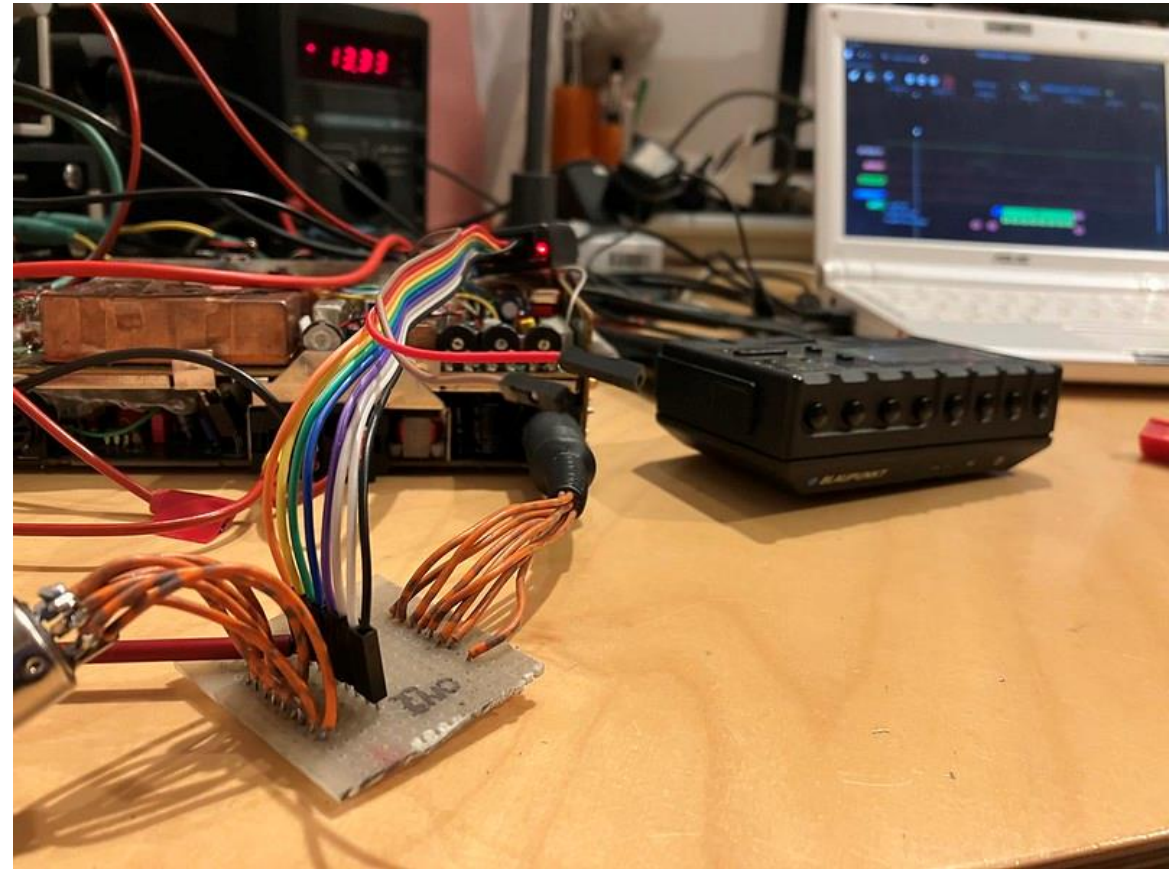
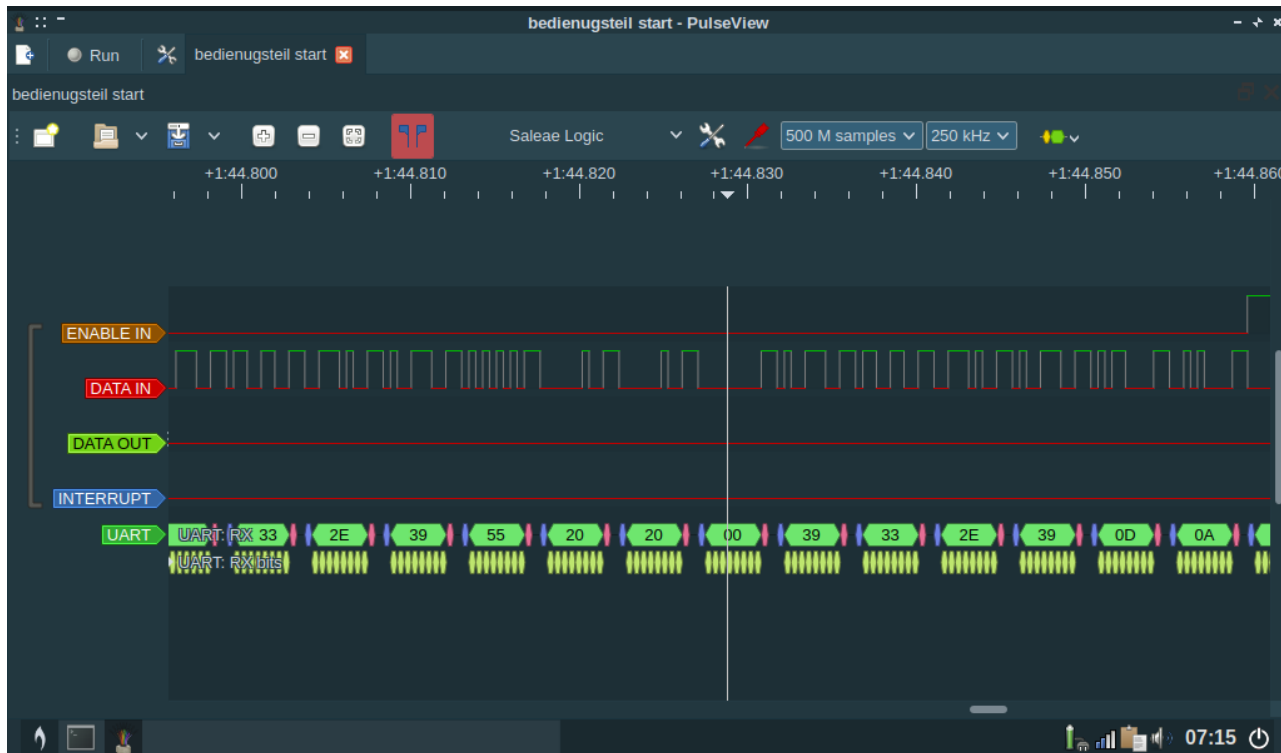
Operator panel communication

I built a connector to tap off the data between the operator panel and the main unit. The interface is indeed normal UART both ways, running at 2400 baud, 8 bits, one start bit.

There is data both with the enable signal from the main unit being high and low, but it seems it's low when there are data being sent to the LCD. Perhaps it's high with other data, e.g. LED's? Data to the LCD is ascii by the way.

Data sent to the display right after power-on... visible UART data converts to this string: ...3.9U <NUL>93.9<CR><LF>...
