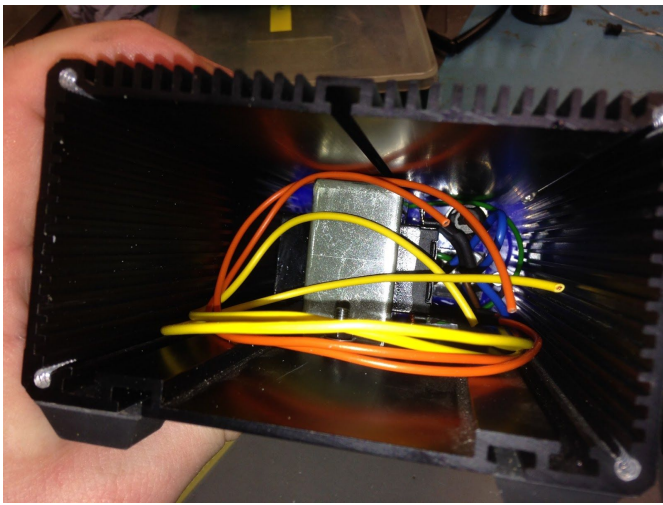
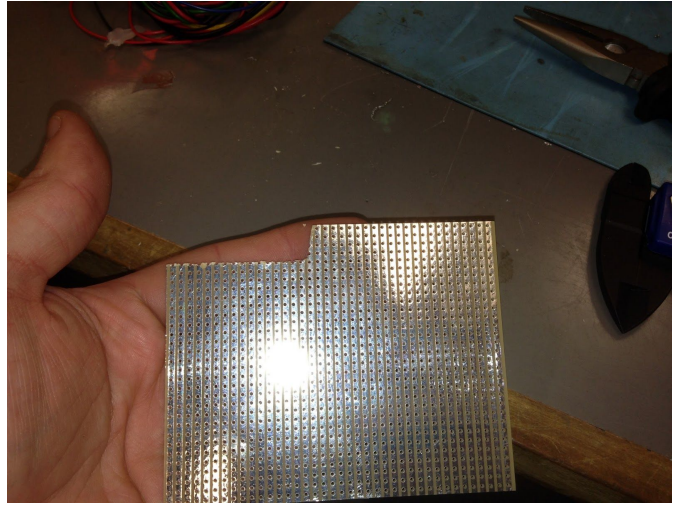
Drilled holes in bottom of case and soldered wires to transformer, fuse holder and IEC inlet, then mounted Transformer into case. Next I cut some strip board to size and cut out a corner to accommodate the connections to the binding posts.

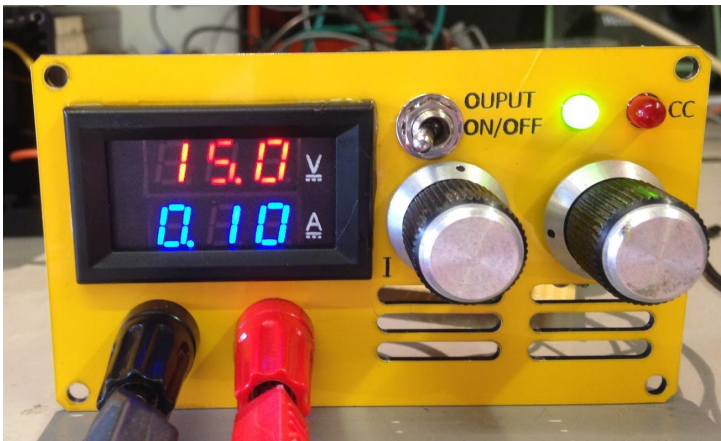
Load test at higher voltage with 150R load.

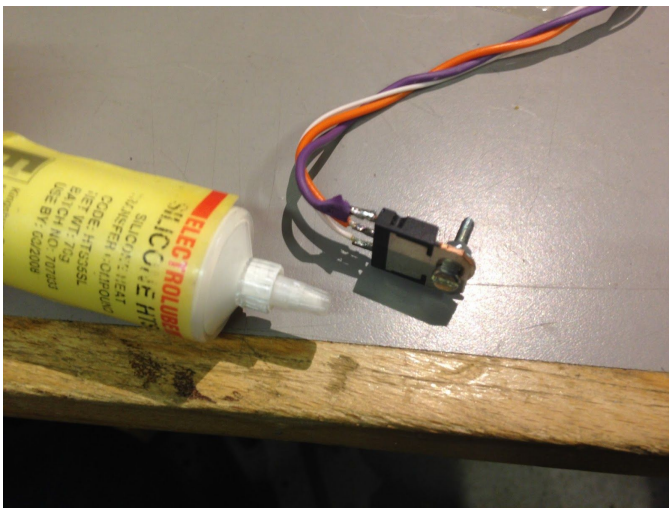
Applied a small amount of thermal paste to transistor and bolted it to slot in case roof with modified M3 bolt (sides of bolt head we're squared off)

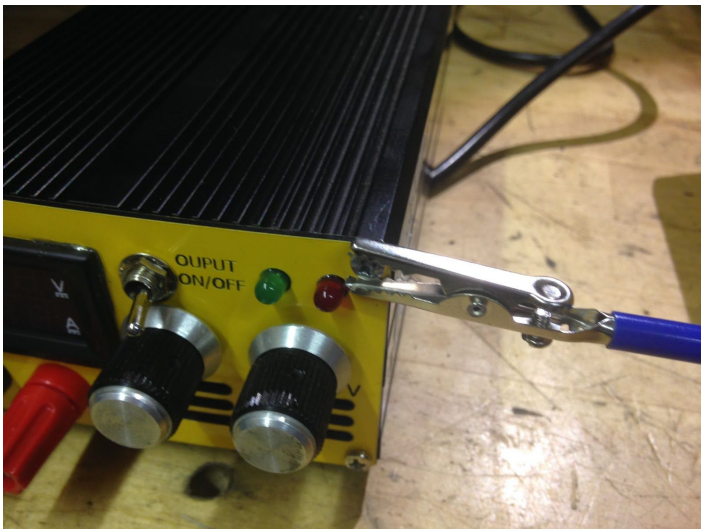
Earth Bond test position 2 and the result

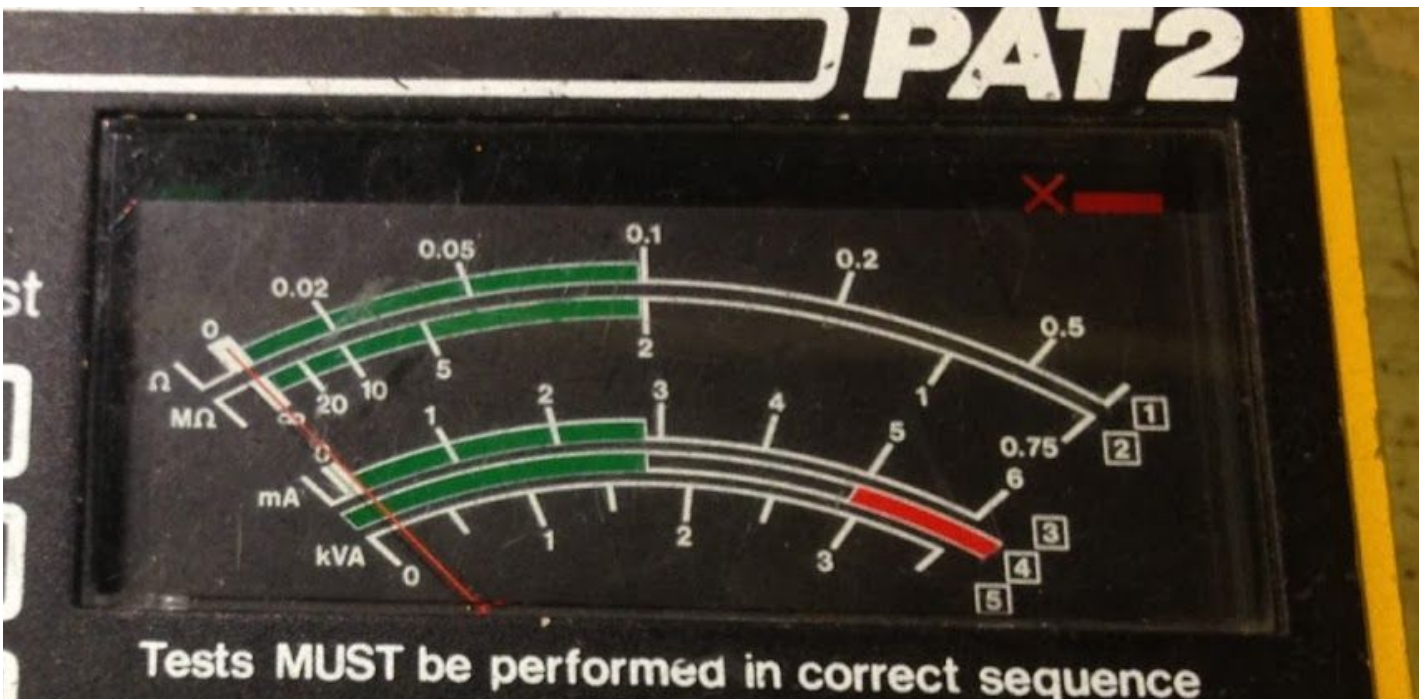
Insulation test result and Earth bond test position 2. All good! All Safe!
